Manhole Inspection Summary

Manhole # S13S__018MH

Location Address: **1009 Parksley Ave**

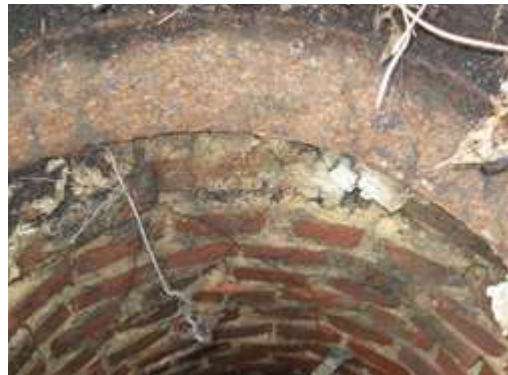
Defect 4

Infiltration: ☐ None ☒ **Joint** ☐ Cracks ☐ Mortar ☐ Roots ☐ Wall

chimney infiltration at frame joint

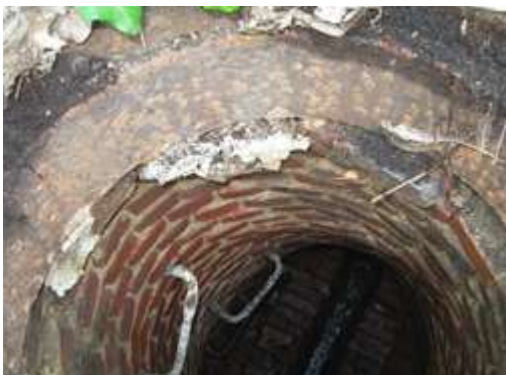
Defect 2

Frame Offset: **2** (in.) Condition: ☒ Sound ☐ Cracked ☐ Leaks

frame offset 2 inches

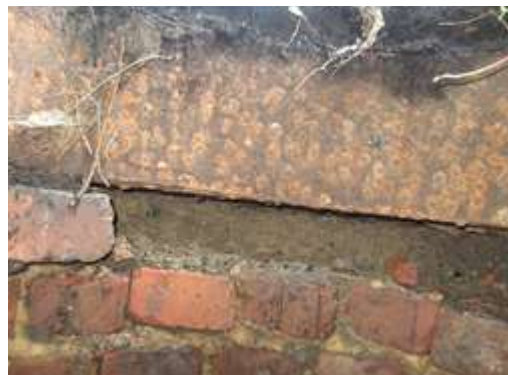
Defect 1

Condition: ☐ Sound ☐ Cracked ☐ Root Intrusion ☒ **Loose Brick** ☐ Deteriorated

chimney loose bricks

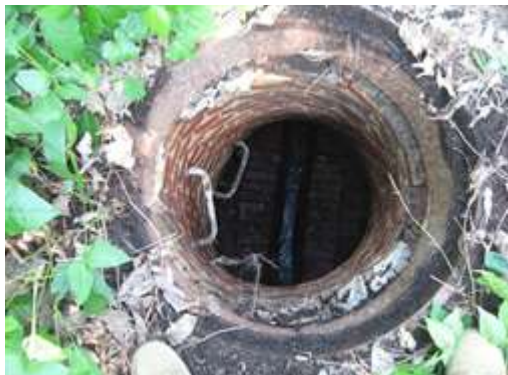
Defect 3

Steps Count: **4** Missing: **0** ☒ **Corroded**

steps corroded

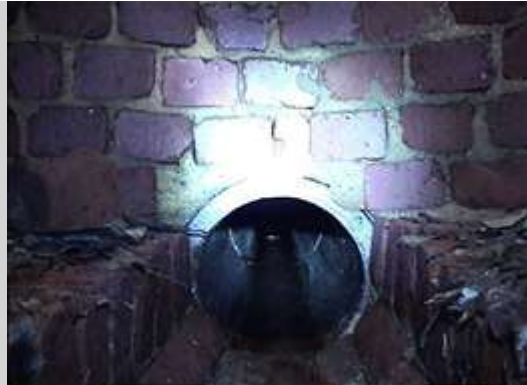
12 O'Clock Outflow

Pipe Height: **8.4** (in.) Rod and Bar (Angled)
Pipe Material: **Clay** ☐ Pipe Lined
Invert Depth: **8.66** (ft.) Flow Characteristics: **Slow**
Deposits: ☒ None ☐ Mud ☐ Sludge ☐ Debris ☐ Grease
Silt Depth: **0** (in.) Deposits Extent:
Infiltration: **Evidence** Pipe Seal Cond: **Unknown**

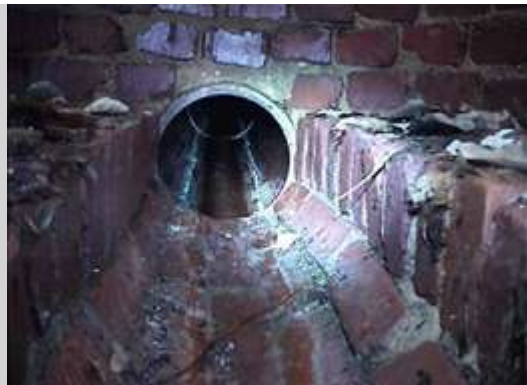
6 O'Clock Inflow

Pipe Height: **8.4** (in.) Rod and Bar (Angled)
Pipe Material: **Clay** ☐ Pipe Lined
Invert Depth: **8.70** (ft.) Flow Characteristics: **Slow**
Deposits: ☒ None ☐ Mud ☐ Sludge ☐ Debris ☐ Grease
Silt Depth: **0** (in.) Deposits Extent:
Infiltration: **Evidence** Pipe Seal Cond: **Unknown**
